Manhole Inspection Summary

Manhole # S39KK_042MH

Location Address: **1714 HOLBROOK ST**

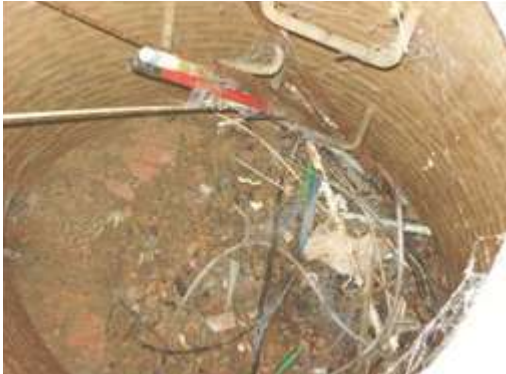
Defect 2

Condition: ☐ Sound ☐ Cracked ☐ Root Intrusion ☐ Deteriorated ☐ Leaks ☒ **Debris**

Debris on bench

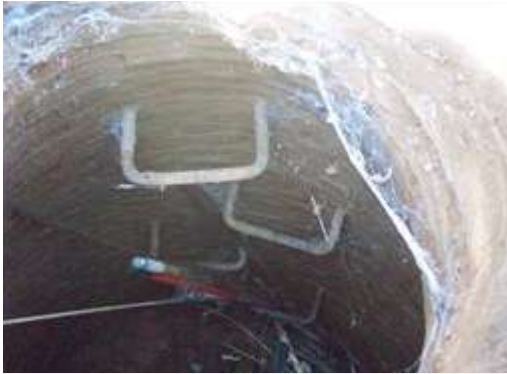
Defect 1

Count: **4** Missing: **0** ☒ **Corroded**

Corroded steps

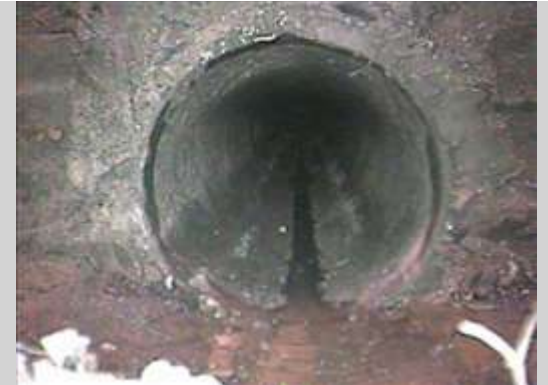
12 O'Clock Outflow

8 in. Circular Gravity Sewer
Pipe Out @ 12 O'Clock

Infiltration: **None** Pipe Seal Cond: **Sound**
